Waste Capture and Audit of Catch Basin LittaTraps™  
in Downtown St. John's, NL

**2020-22 Technical Report**

Jennifer Blundon,  
Northeast Avalon ACAP (Atlantic Coastal Action Program)

June 3, 2022

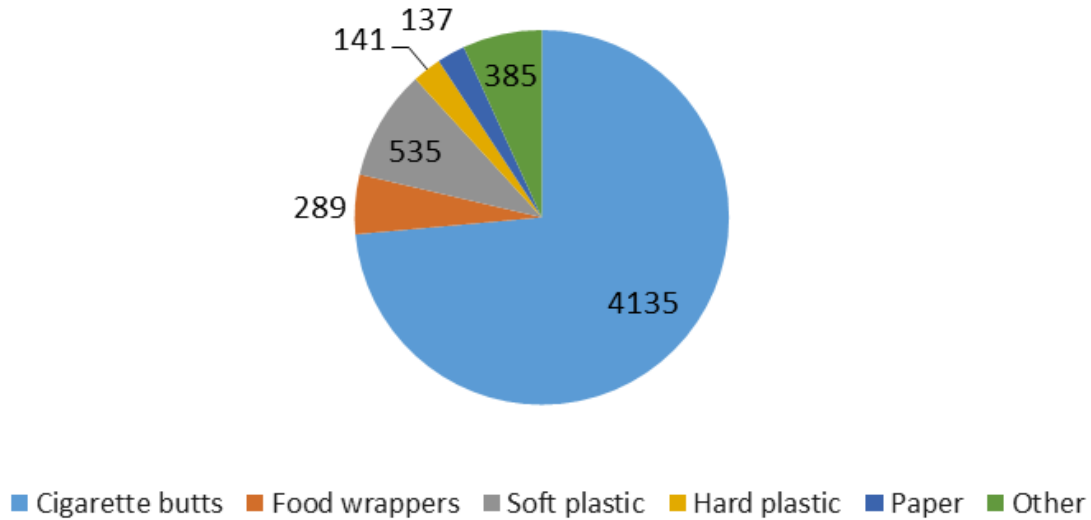
Figure 4: The results of the comparison of the large litter debris counts based on the combined data from the comprehensive June and July characterization audits

As a result, the combined composition of the LittaTraps™ for the months of June and July were primarily comprised of cigarette butts in both count and weight. Counts descend in quantity in the order cigarette butts, soft plastic, other, food wrappers, hard plastic, and paper. Whereas, litter debris by weight descends in volume in the order Cigarette butts, other, soft plastic, paper, food wrappers, and hard plastic. The differences between the descending order of count and weight can be attributed to factors including the size of the pieces, and how much the material absorbs water.

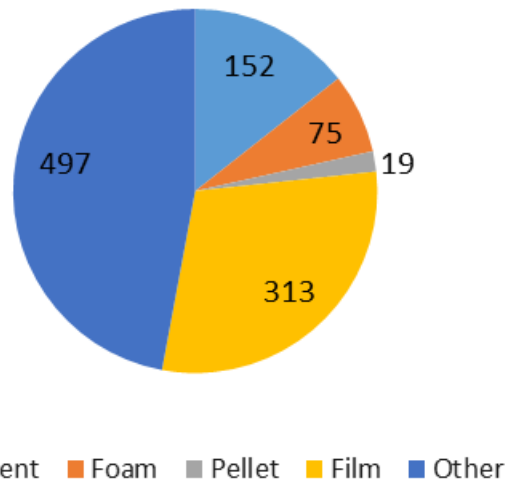
*Figure 6: The results of the comparison of the small litter debris and micro-plastic counts based on the July characterization audit*

From all the sites collected during the July audit, other was the largest collected category, followed by film, fragment, foam, and pellet. Therefore, further contributing to the overall understanding of the types of plastic that is entering the ocean via catch basins in the downtown area.

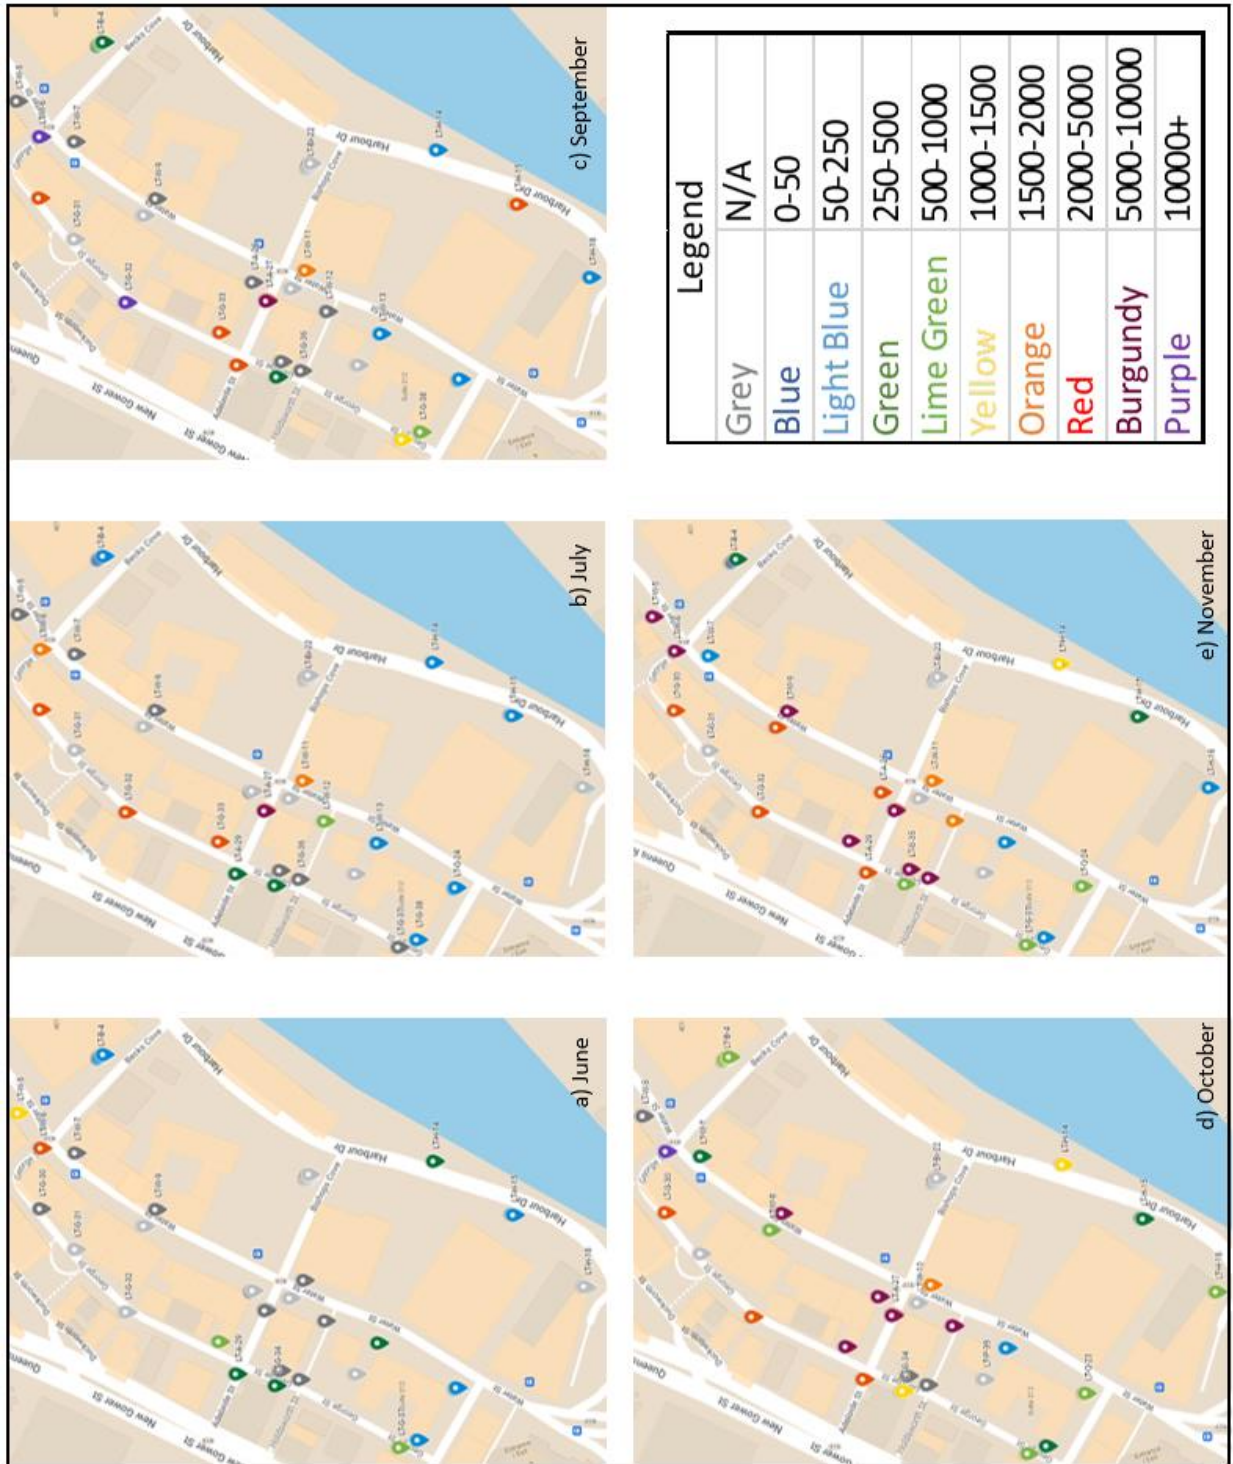
Figure 7: Spatial distribution of LittaTraps™ based on weight (g) at time of collection for the audits in June, July, September, October and November 2021. Colour description; grey represents all traps not installed/inaccessible due to catch basin cover stuck, blocked by car, or deck; the remaining colours indicate the range of the net weight of each LittaTrap contents in grams at the time of audit.

As a result, the spatial distribution of volume of litter debris collected is evident in both the map and table below, where certain traps routinely had high initial weights. These sites were primarily located along George Street and Water Street between Adelaide Street and where George Street becomes Becks Cove. Where as sites located along Becks Cove, Harbour Drive, and Queens Street had lower collected volumes. This is because of the frequency and type of use experienced at the various site locations by people, and that George Street and Water Street are the first to receive litter debris being washed downhill by storm water. Thus, suggesting that spatial gradient of volume received at the various sites across downtown St. John's. However, there is several discrepancies that occurred that may skew results slight such as traps that were left uncollected for more than one month as a result of stuck grate covers, cars parked blocking access, and the installation of decks for the summer/fall season. These discrepancies are outlined in the Table 1, and unlike the occurrences of temporarily inaccessible catch basins, the catch basins that were covered by decks provided important feedback. They allowed the further understanding of the reality that despite being blocked, litter debris still managed to wash into the catch basins, and that the LittaTraps™ were able to be left for up to 5 months without intermittent retrieval and did not over flow with debris, nor did they block the flow of water.

Lastly, Figures 7 and 8 do demonstrate that there is temporal distribution of the collected debris, where there was more debris collected in the fall than in the early summer. However, as previously mentioned this may not accurately represent the volume of plastic debris collected to the volume of natural inorganic and organic debris. This warrants that further detailed composition analysis via photo analysis and/or additional field seasons may increase the knowledge of whether the temporal distribution is solely related to plastic debris. However, for the purpose of this study, this data allows for the improved understanding of use of LittaTraps™ as a management tool for preventing all types of debris from entering the catch basin system and subsequently the ocean including large amounts of litter debris as proven in the June and July audits.

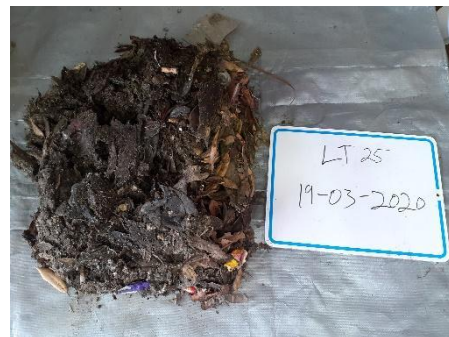
1. Place a covering over the work area such as a tarp or plastic sheet.
2. Put on PPE
3. Record the site name, collection date, date of sorting, and moisture content of the sample (dry or wet)
4. Weigh the sample to the nearest 100 g. Record the value.
5. Empty the sample container onto the designated sorting area and capture a photo of the sample next to a small white

board or similar item that shows the site name and collection date.

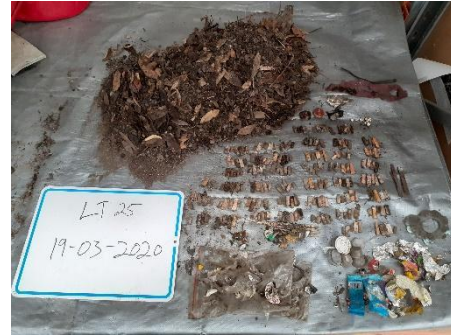
10. Place the litter into containers according to category. These containers will hold the total litter captured throughout the study for a visual representation of the total litter captured.

11. Place the Organics/sediment back into the original container if sediment samples are to be taken, otherwise store or dispose according to preference or practicality.
